**National Park Service  
Cultural Landscape Inventory  
2006**

**Kilauea Administration and Employee Housing Historic District  
Hawaii Volcanoes National Park**

**Kilauea Administration and Employee Housing  
Historic District  
Hawaii Volcanoes National Park**

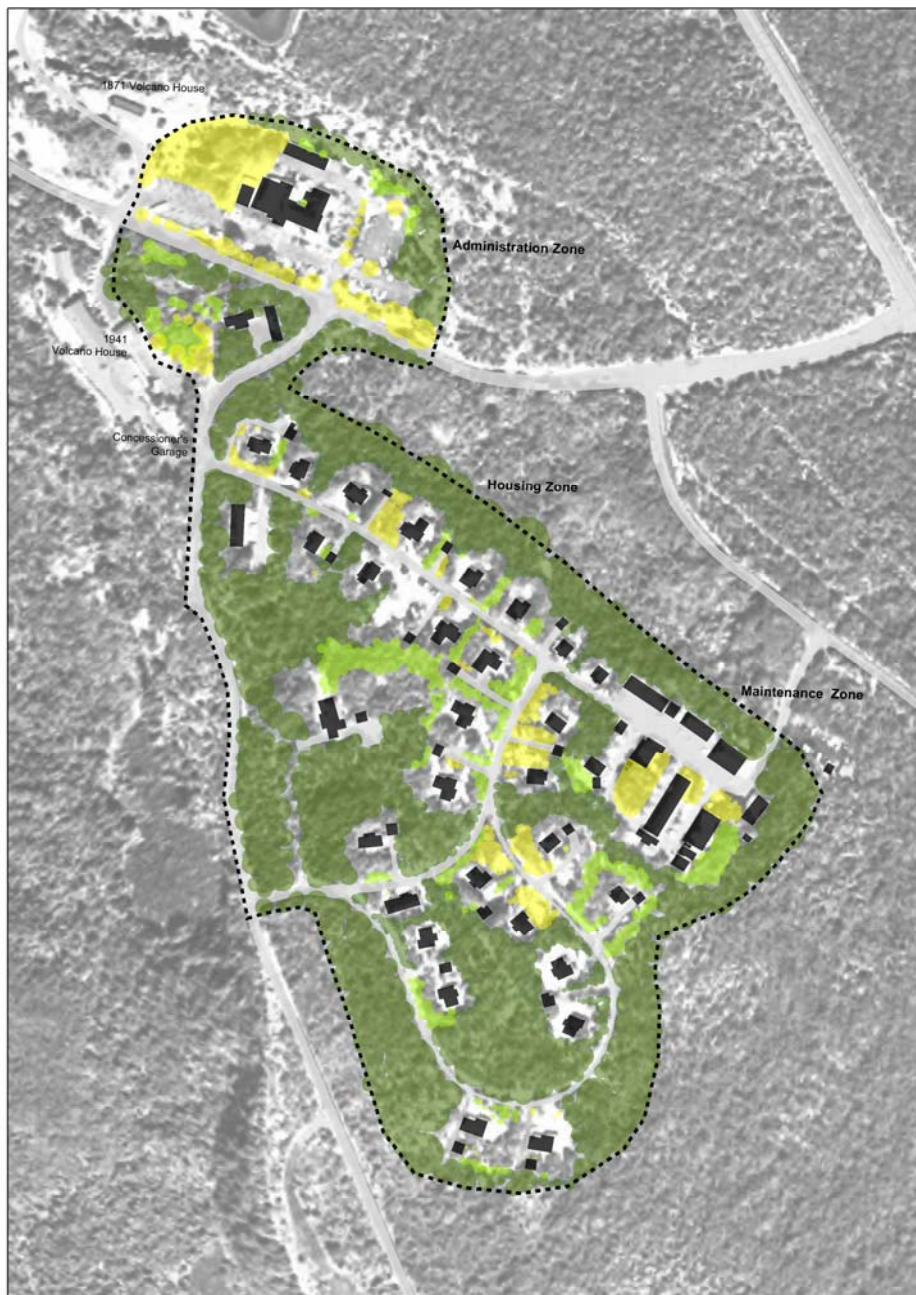
**Site Map 2. Vegetation Patterns**  
**Kilauea Administration and Employee Housing Historic District**

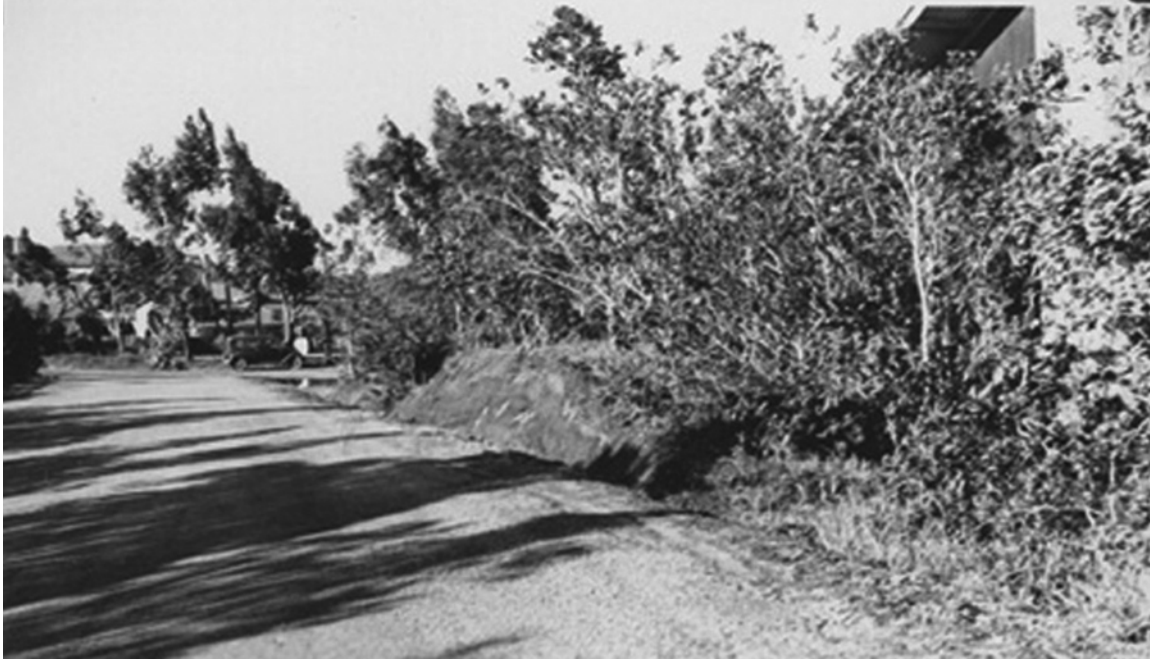
Figure 1. Photograph from the 1939 landscape architect report showing rounding of road banks (1939 Landscape Architect Report, HAVO Archives).

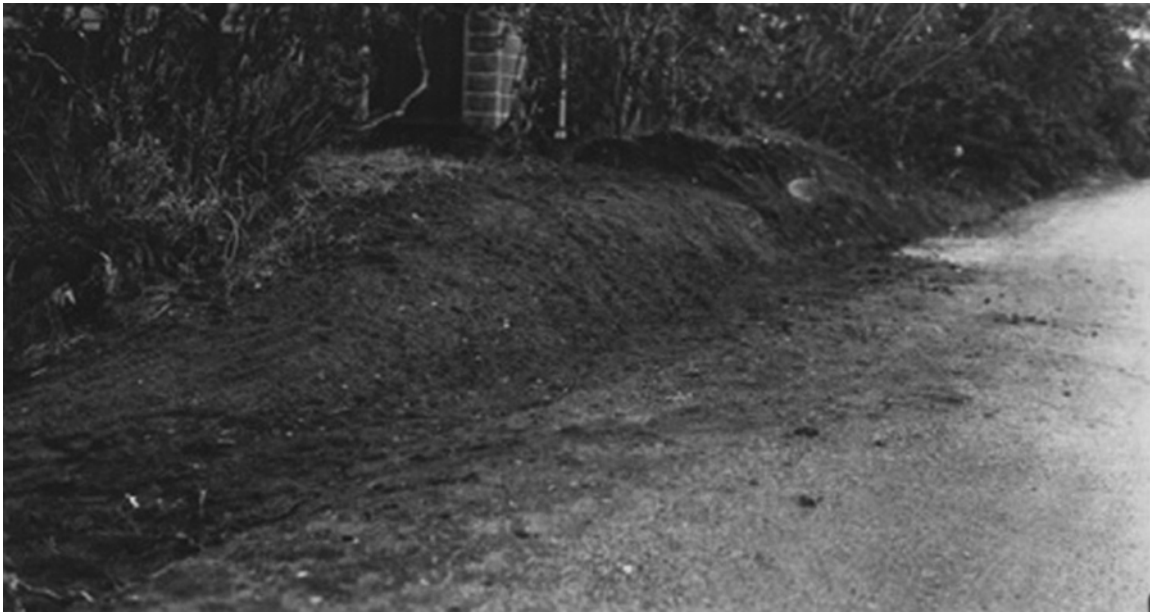
Figure 2. Photograph from the 1939 landscape architect report showing rounding of road banks (1939 Landscape Architect Report, HAVO Archives).

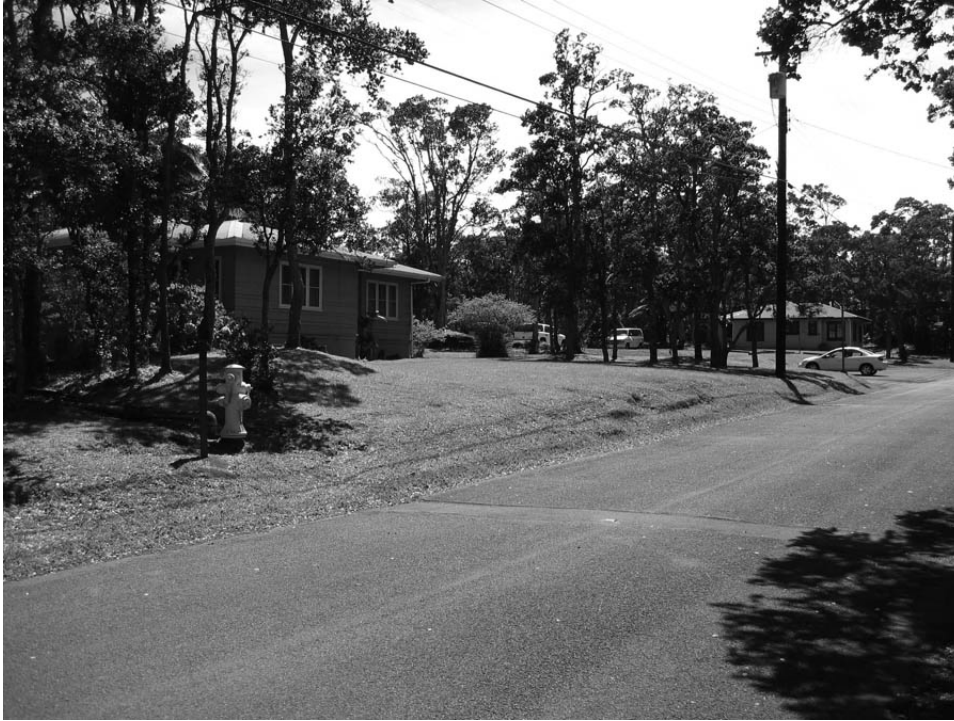
Figure 3. Lots were graded to create boundaries between the units—Employee Quarters No. 19 (PWR Staff—2005).

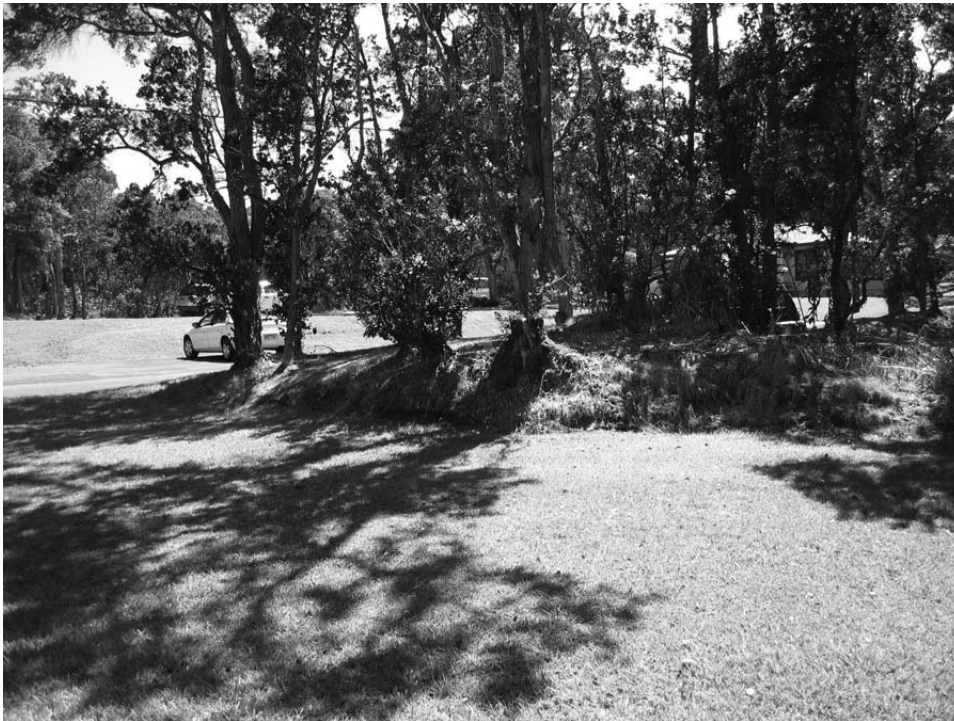
Figure 4. Change in elevation between two residences. The grading and lot boundaries are further accentuated with vegetative screening (PWR Staff—2005).

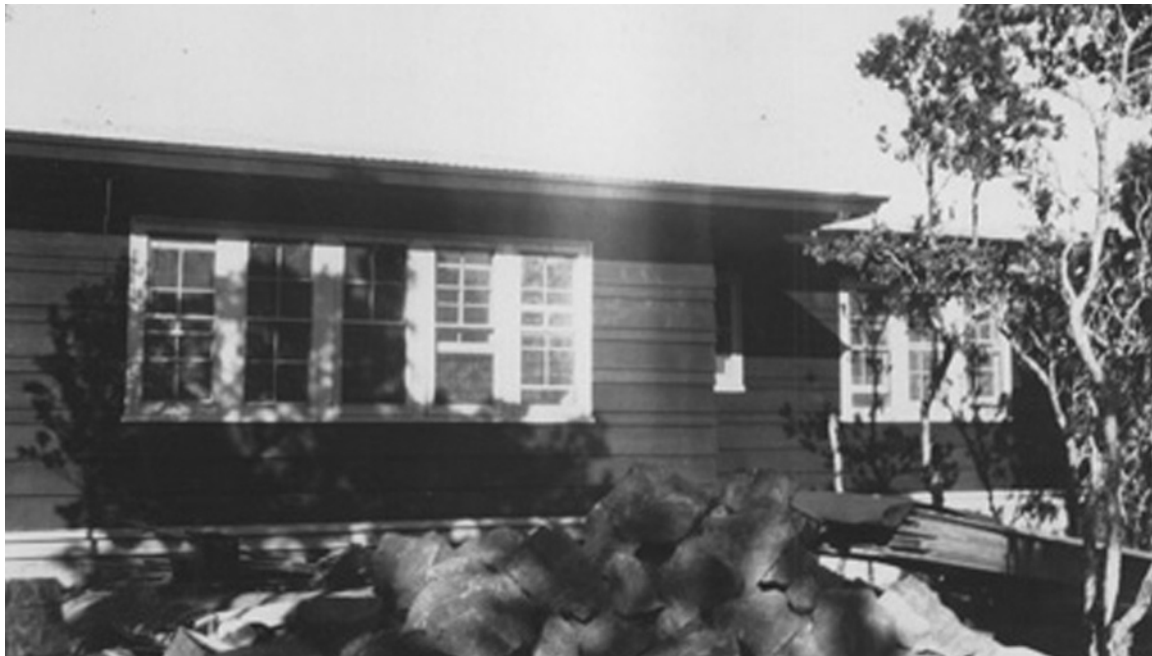
Figure 1. Employee Residence being built (1945 NPS Travelogue, HAVO Archives).

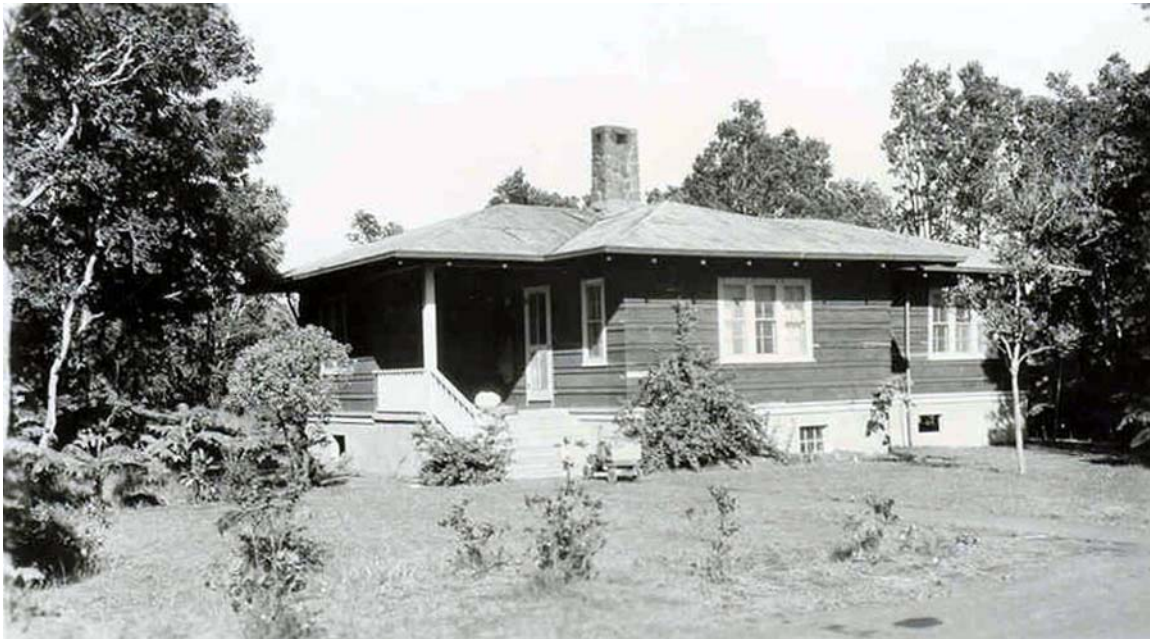
Figure 2. Example of a typical residence (Employee Quarters No. 22) ca. 1945, approximately six years after it was built. The building was designed to blend in with the surrounding native vegetation. (1945 NPS Travelogue, HAVO Archives).

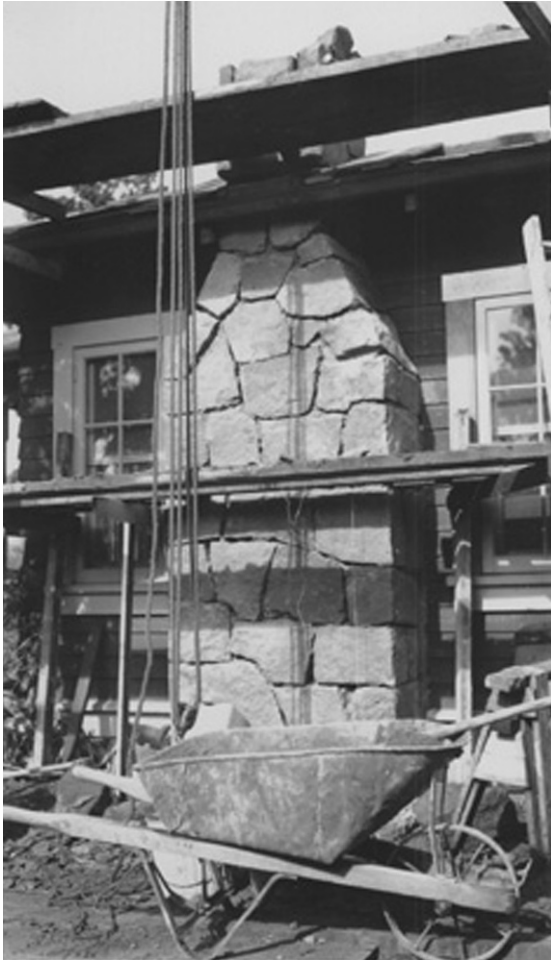
Figure 3. Stone chimney being added to Employee Quarters No. 5 in 1934—six years after the residence was built (1934 Landscape Architect Report, HAVO Archives).

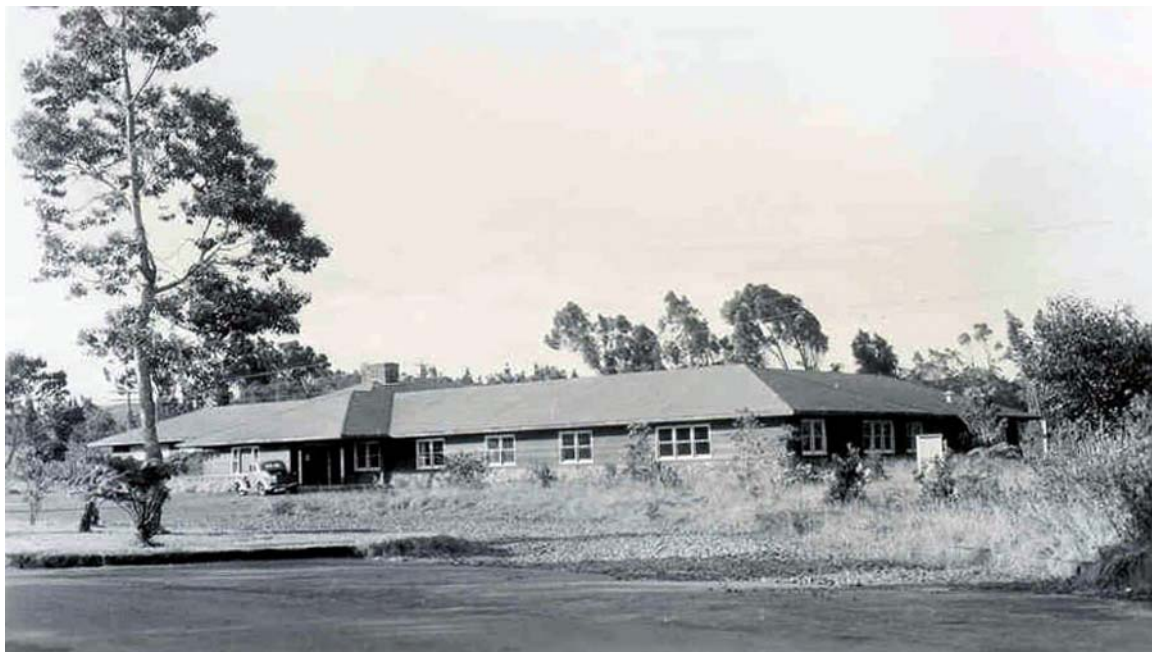
Figure 5. Administration Building after completion in 1942 (1945 NPS Travelogue, HAVO Archives).
